4TH FLOOR BOILER HOUSE SECTION VII ROOM 7.06 G

**Non-TCRA Building Assessment
Avtex Fibers Superfund Site**

POLYESTER SPINNING FOURTH FLOOR SECTION 1

POLYMER PLANT 4TH FLOOR SECTION 1 ROOM 1.05 E

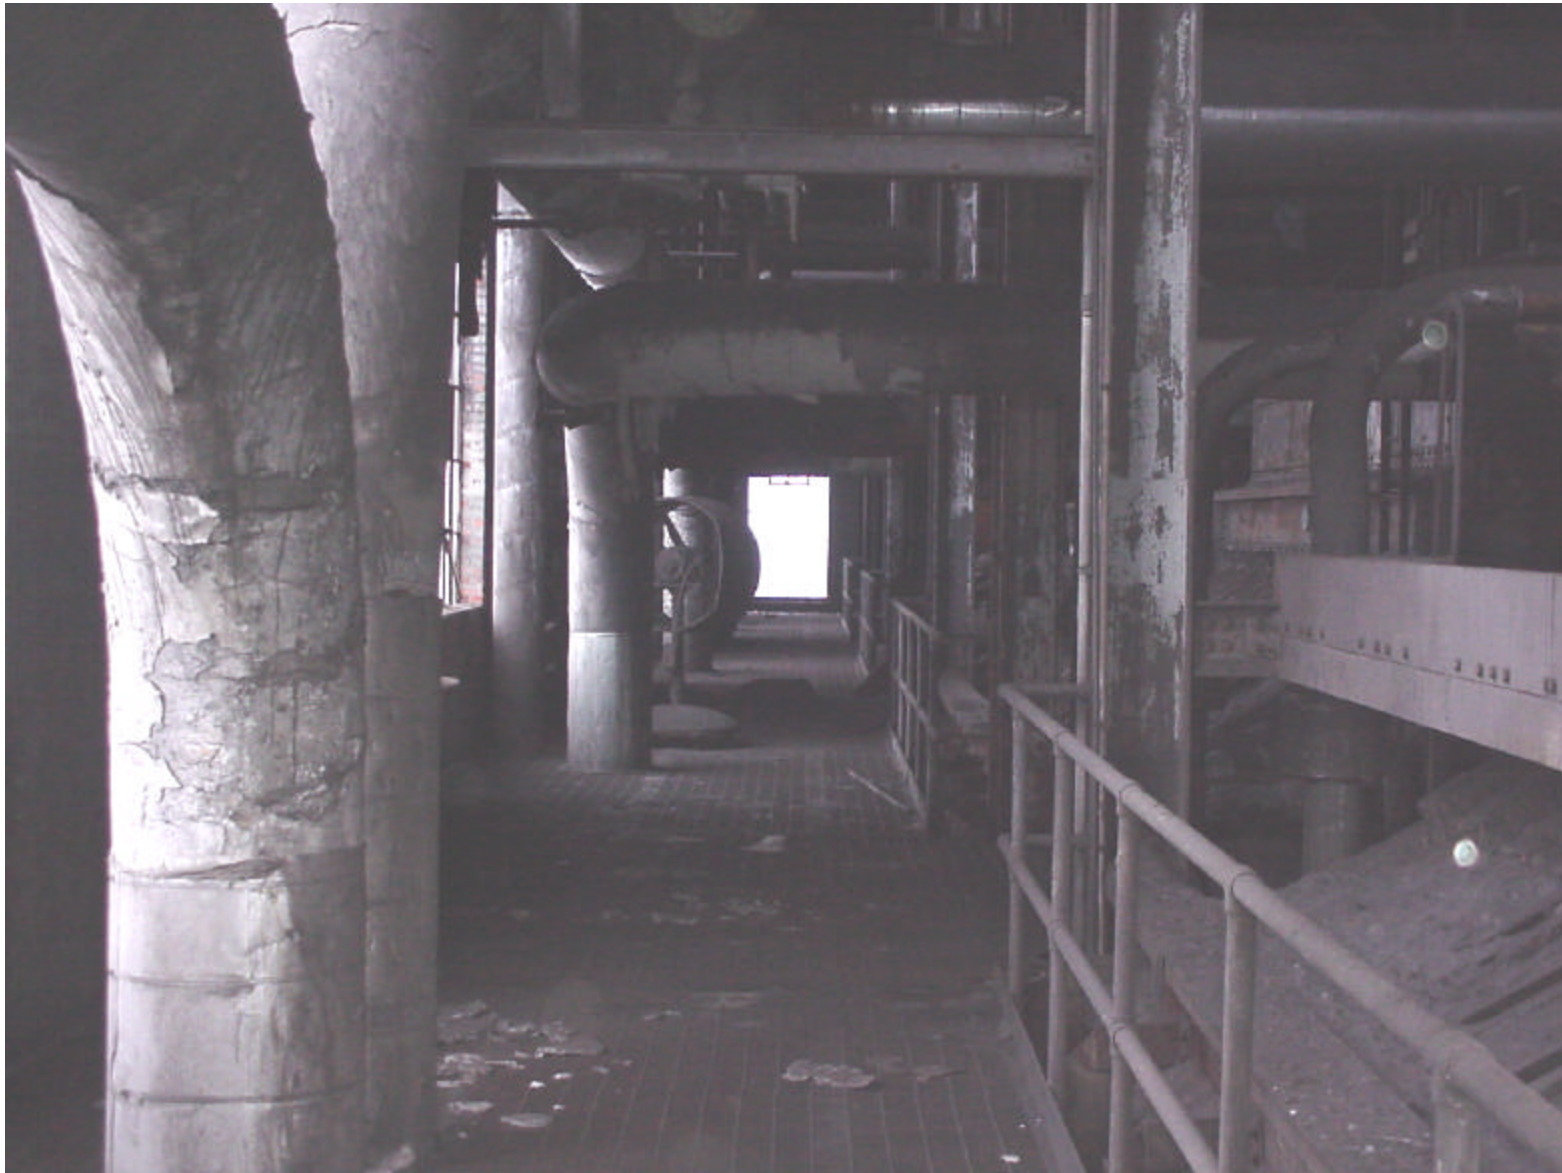
Photograph ID	Date Taken	Section #	Room #	Room Description	Description
MVC-693		VII	7.06G	4nd Floor Boiler House	Looking east from northwest corner room

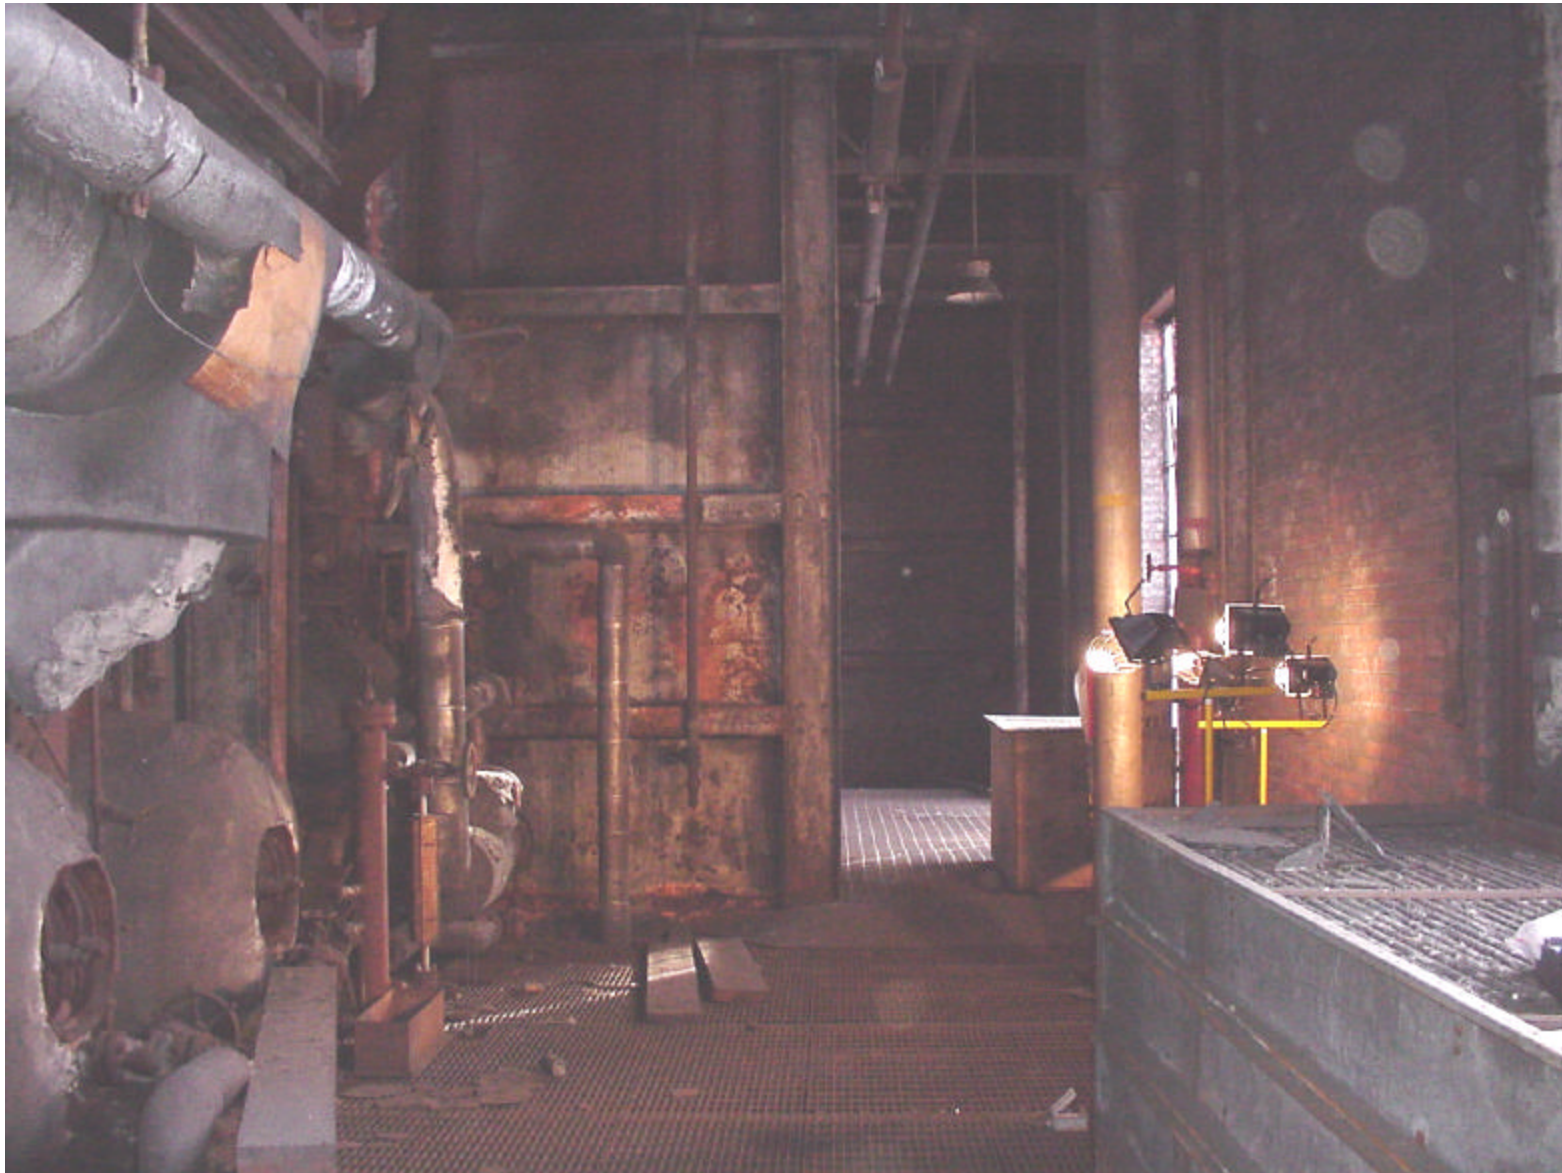
Photograph ID	Date Taken	Section #	Room #	Room Description	Description
MVC-694		VII	7.06G	4nd Floor Boiler House	Looking south from northwest corner of room

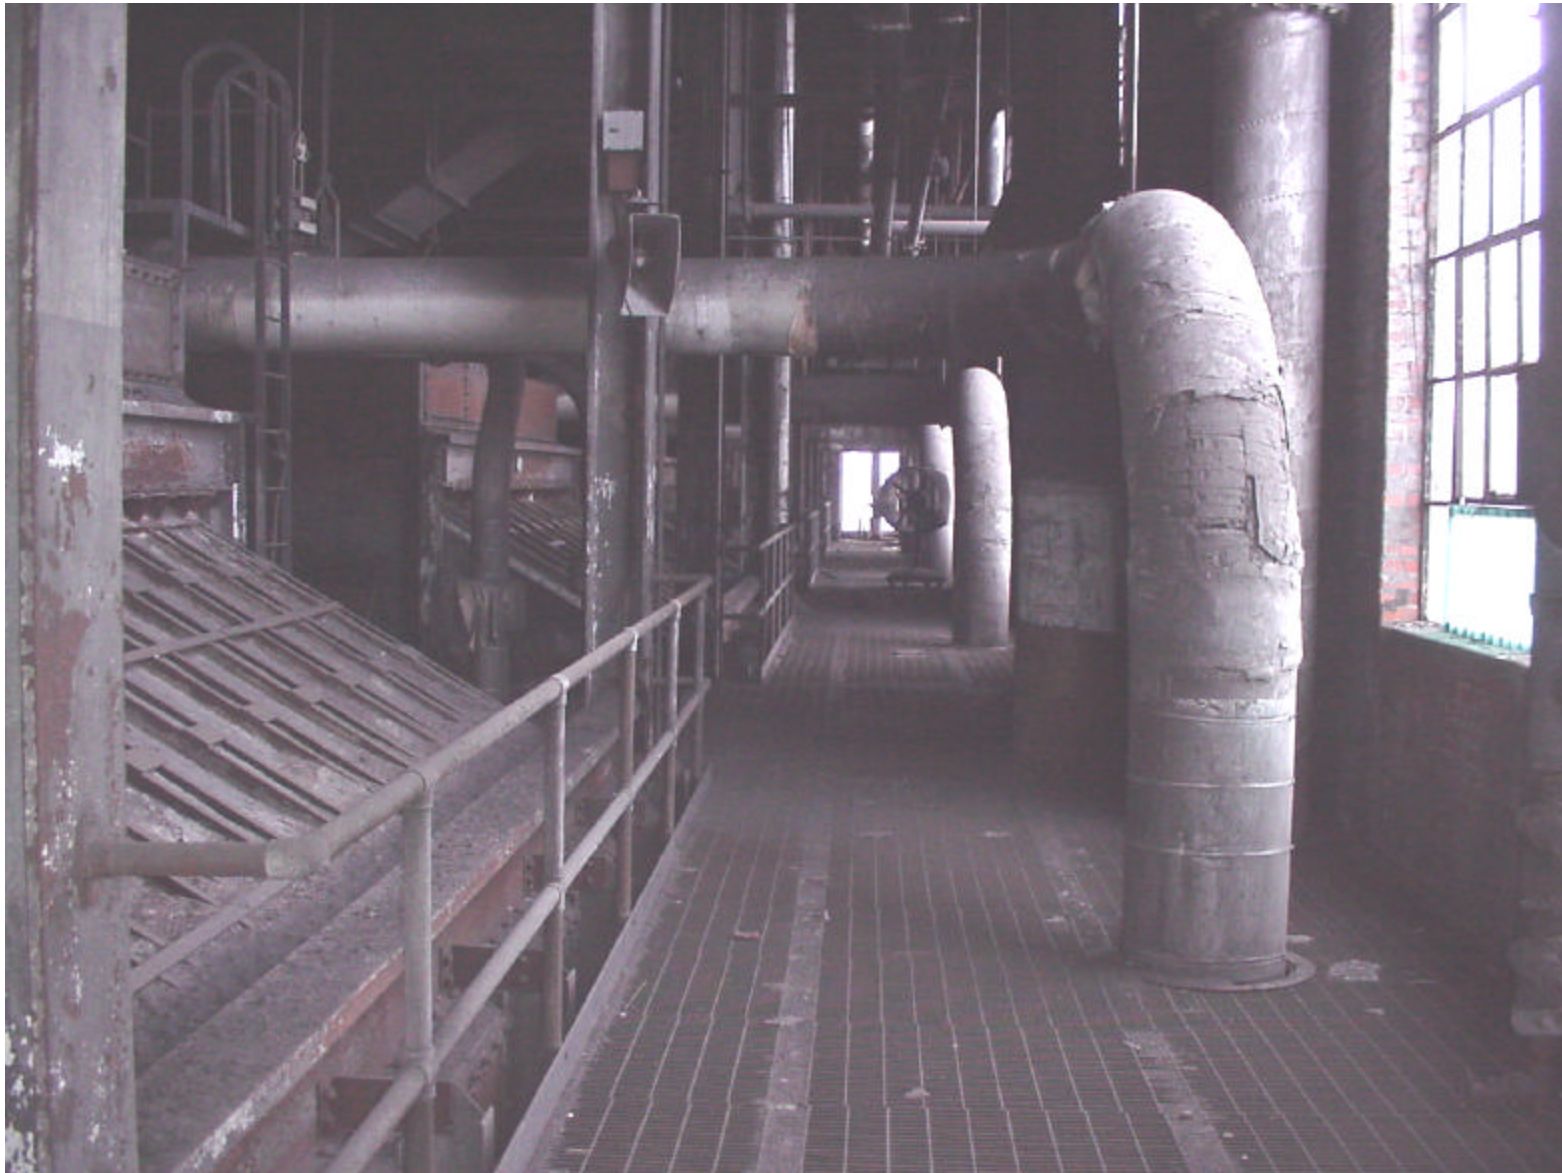
Photograph ID	Date Taken	Section #	Room #	Room Description	Description
MVC-696		VII	7.06G	4nd Floor Boiler House	Looking west from northeast corner
